Peel Harvey Catchment Council - Hotham-Williams River Action Plan

Figure 3 - Pumphreys bridge site concept

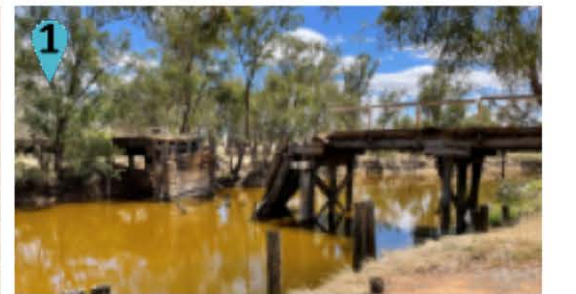
1 Remnants of the old bridge-deck have been left hanging in the river channel and may be unsafe. A structural inspection is recommended to determine how much of the structure can be retained and repurposed (see note 11).

- 11 Existing remnant bridge deck made safe and repurposed as viewing platform with historic information board.
 - 12 Principal information board with history of bridge/CWA/recreation ground and map of main footpaths and facilities.

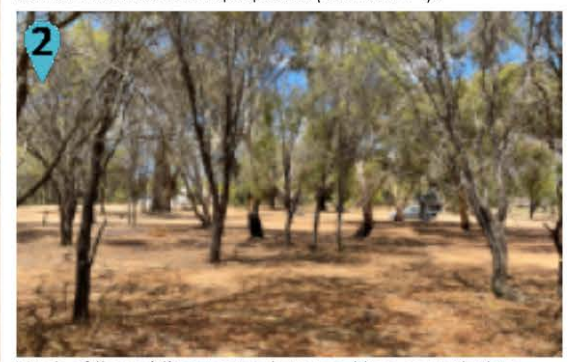
2 Much of the existing reserve has good tree cover but no understory. These areas provide opportunities for shaded camping alcoves (see note 7).

- 7 Overnight camping areas with informally marked bays using existing and newly planted trees to create alcoves.
 - 8 Existing cleared area near camping with few trees to be repurposed as firepit or barbecue area with adjacent picnic benches or shelters.
