## Groundwater study of the Wandering townsite

# GROUNDWATER STUDY OF THE WANDERING TOWNSITE

**RESOURCE MANAGEMENT  
TECHNICAL REPORT 260**

**Rural  
Towns  
Program**

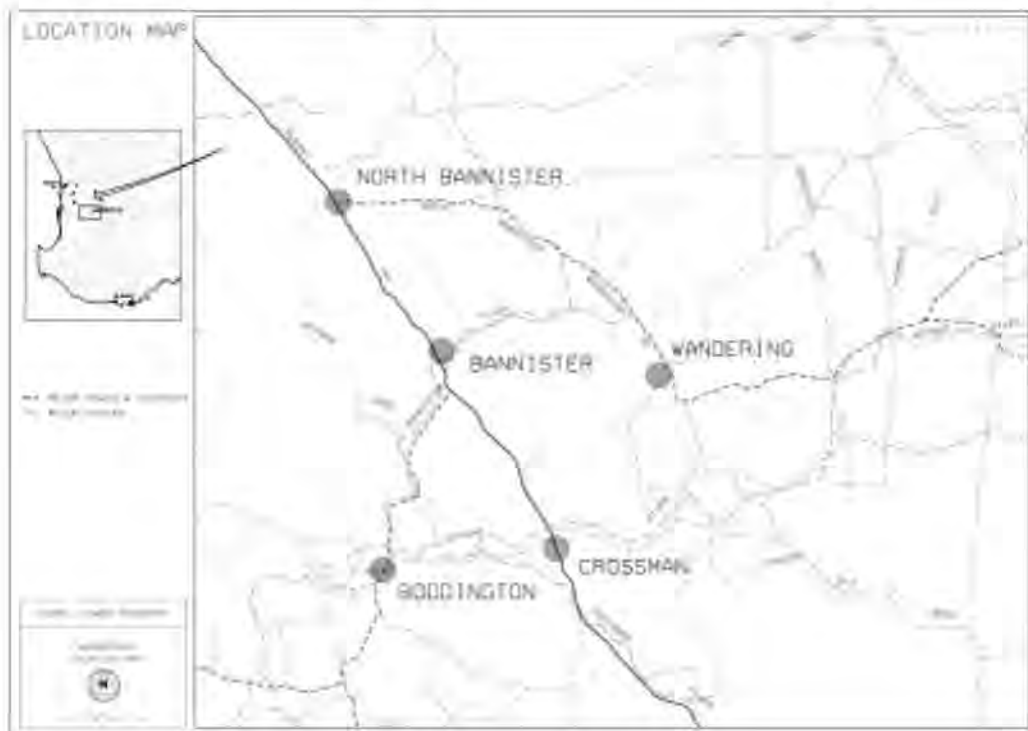
Figure 1-1. Regional setting of Wandering townsite

Wandering is located about 110 km south-east of Perth (see Figure 1-1). It has a population of about 80 people and provides services for around 400 more in the surrounding district. Farming of cereals and livestock is the major industry, with viticulture and tourism becoming increasingly important. A community centre was built in 1986 and new residential land has been developed recently, reflecting community growth trends.

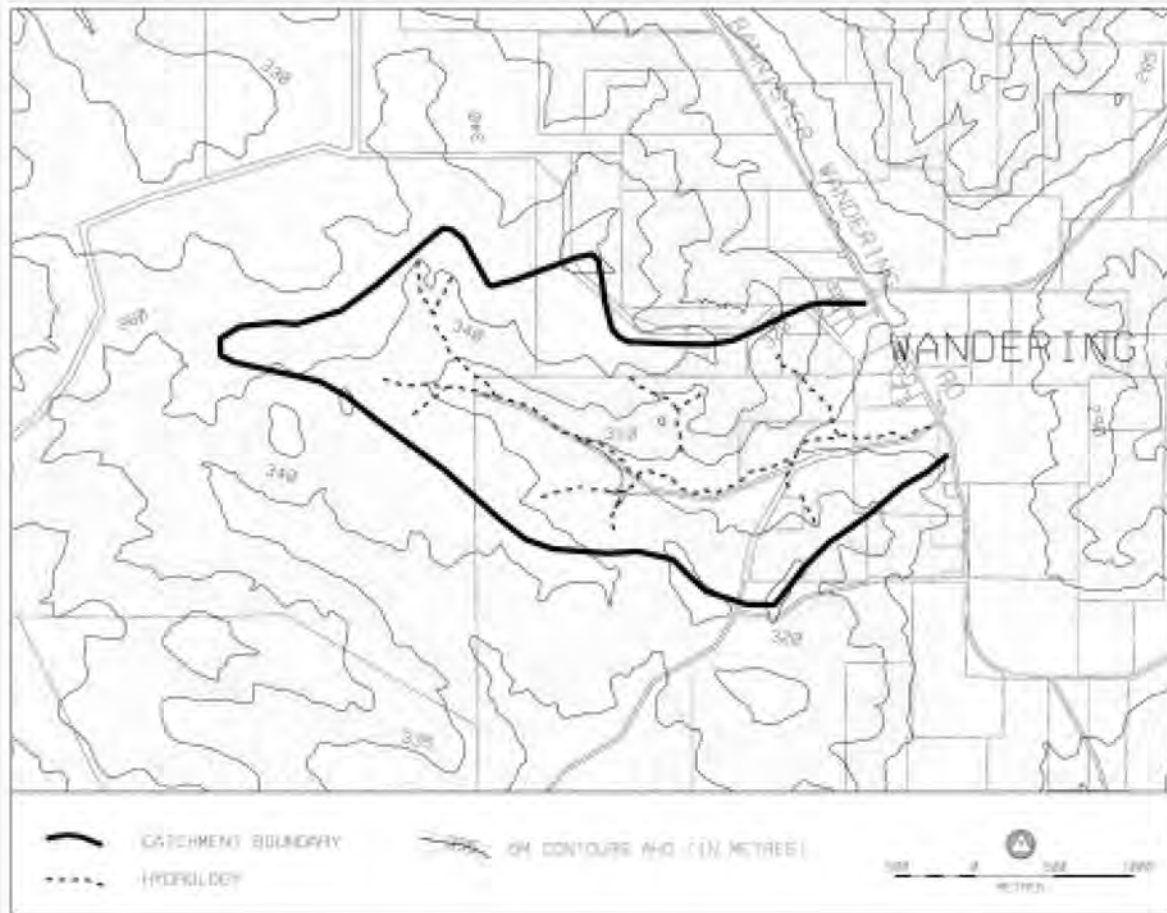
Figure 1-2. Location of the Wandering townsite in its catchment

Wandering is located in an elongated, unnamed 540 hectare catchment (hereafter referred to as the Wandering catchment). The catchment extends approximately 4 km westwards from its Wandering Brook discharge point, and is between 1.4 and 1.8 km wide along most of its length. Much of the north-east divide is covered with remnant vegetation. Figure 1-2 shows the location of the townsite and catchment topography.

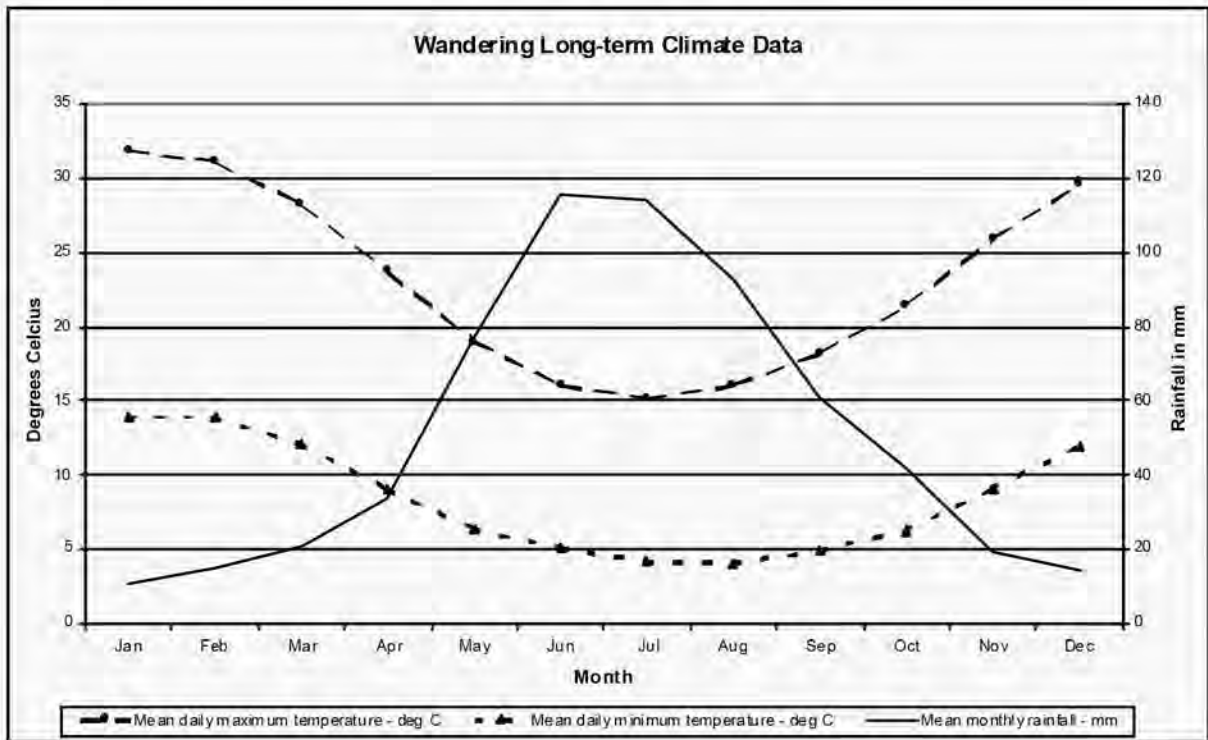
Figure 1-3. Mean monthly temperatures and rainfall for Wandering

Wandering townsite has been an official Bureau of Meteorology weather station since 1887 (BOM 2002) therefore accurate data is readily available. Mean annual rainfall is approximately 615 mm, with May to October being the wettest period. Mean daily temperature variation in summer is 13.9 to 31.8°C and in winter 4.2 to 15.2°C. Figure 1-3 shows some long-term climatic data.

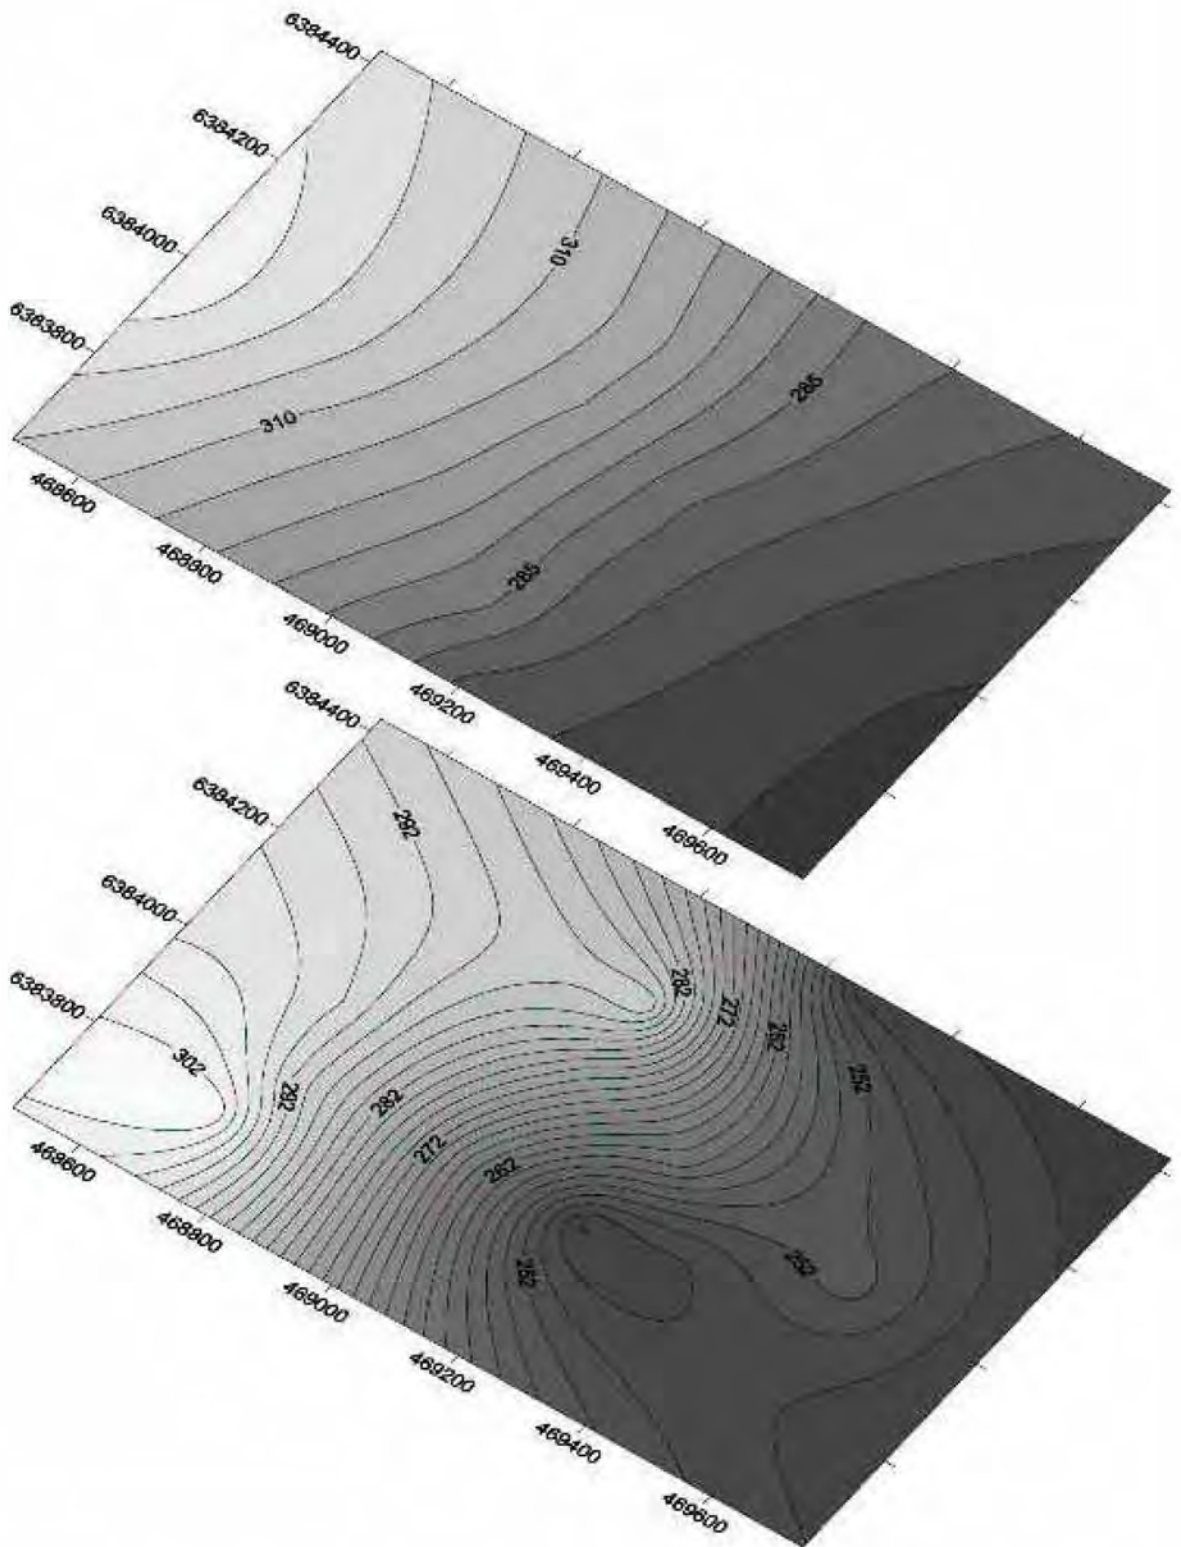
Figure 2-2. Surface topography (top) and bedrock (bottom) elevation contour maps (for contoured area shown in Figure 2-1)

The apparent sump in the bedrock surface is a result of drilling directly into a mafic dyke (02WR10D). As depicted in the cross-sections (Figures 2-3 to 2-5), mafic bedrock will weather to clay more deeply than surrounding felsic bedrock.

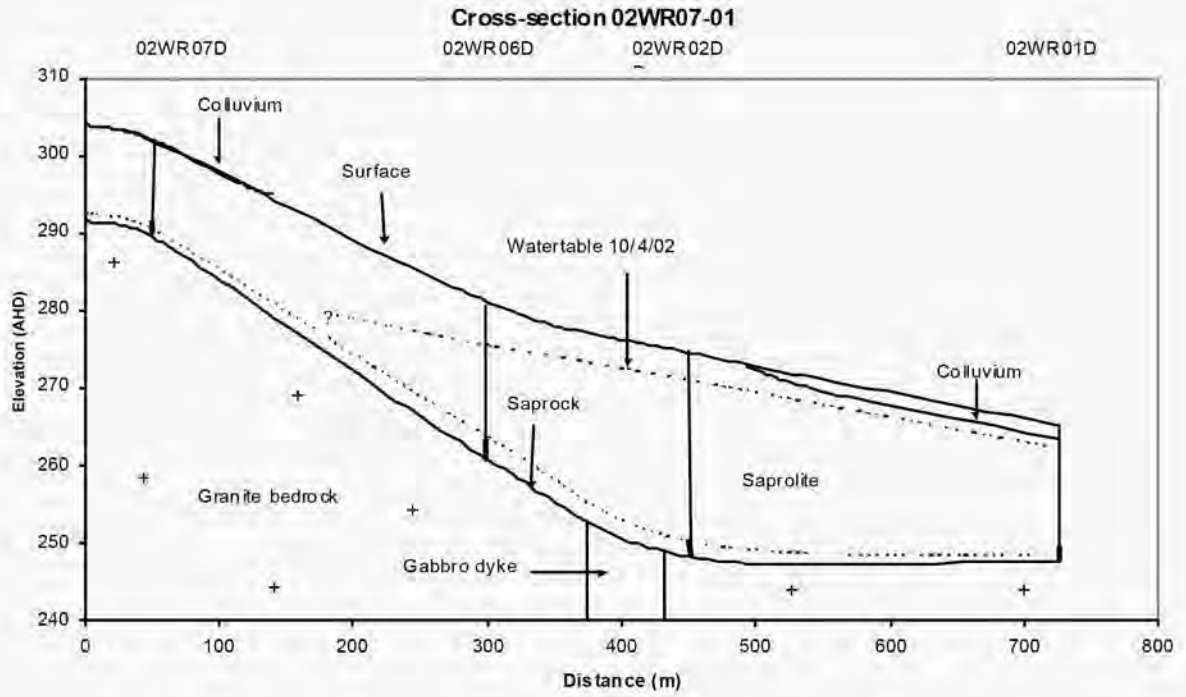
Figure 2-3. Cross-section from drill site 02WR07 to 02WR01

Regolith in Wandering consists of shallow laterite-derived gravel and/or clay colluvium deposits overlying primarily granite saprolite. All drill holes intersected coarse-grained granite bedrock with only one drilled directly into a gabbro dyke (02WR10). Complete regolith profiles are present to the west of the town. Both gabbro and granite weathered material is present on ridges, and unweathered rock outcrop was only observed at erosional surfaces. The profiles are illustrated in cross-section (Figures 2-3 to 2-5).

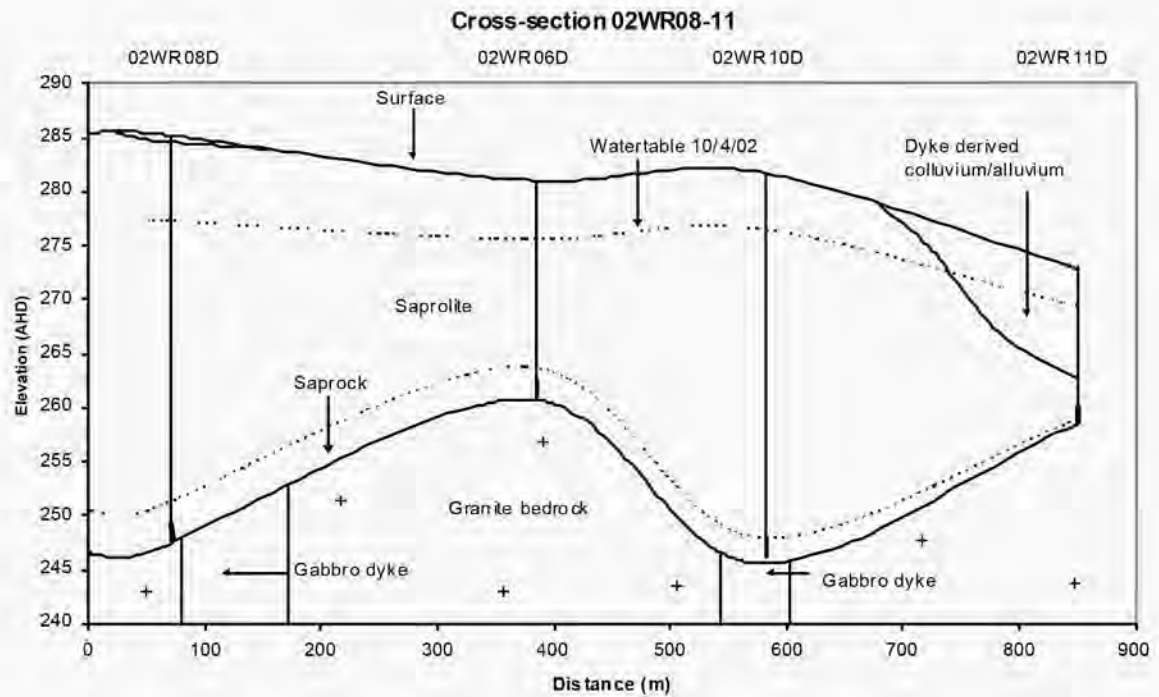
Figure 2-4. Cross-section from drill site 02WR08 to 02WR11

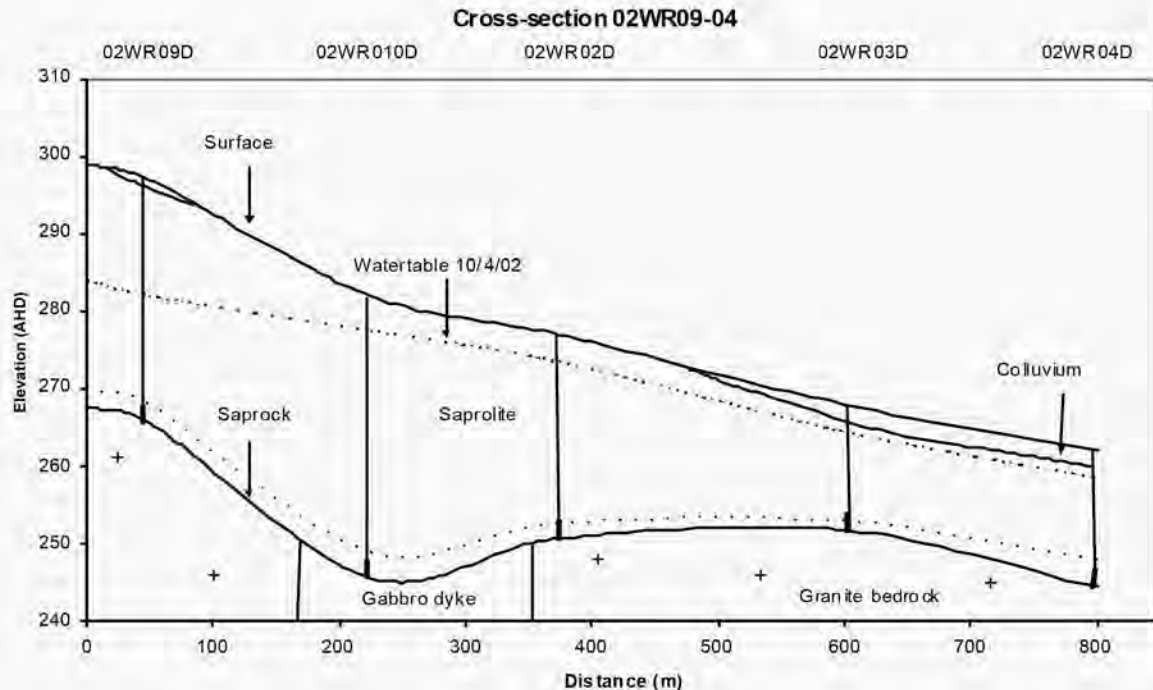
Figure 2-5. Cross-section from drill site 02WR09 to 02WR04

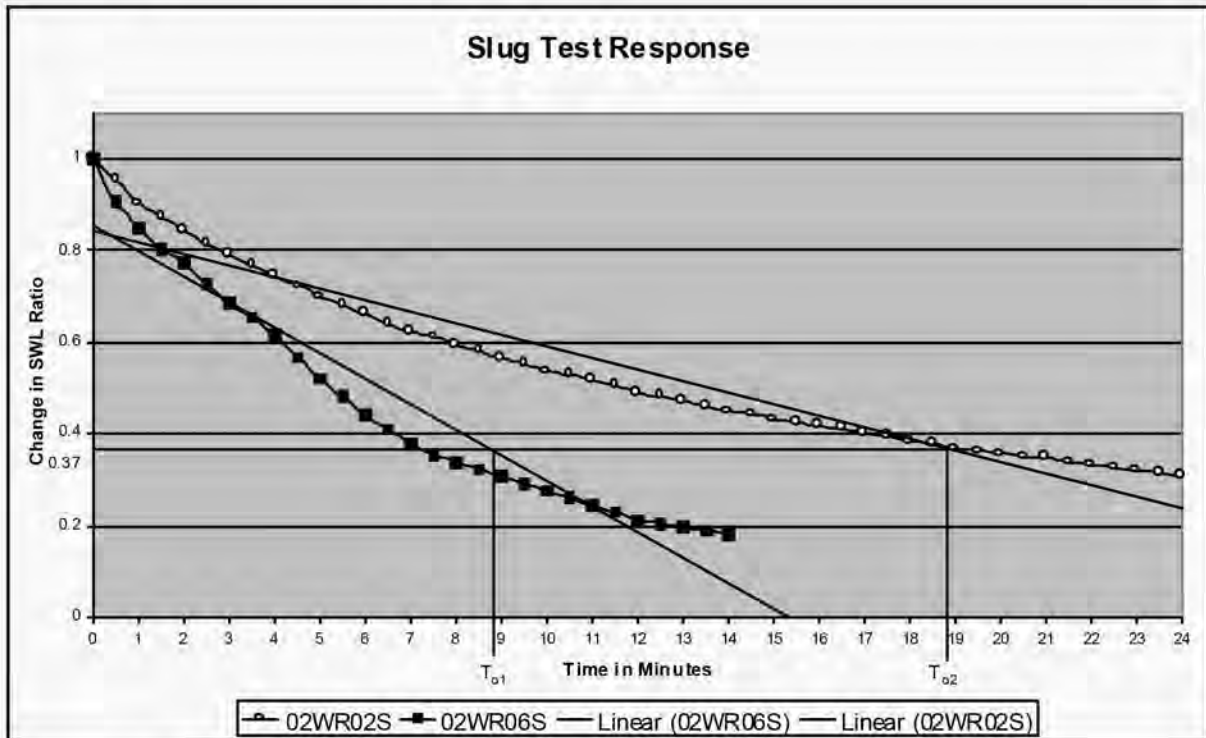
Figure 2-6. Slug test ratio graph showing 02WR06S recovered faster than 02WR02S

Slug tests were performed on four shallow piezometers (02WR02S, 02WR06S, 02WR10S, RTPWPZ5) and the Hvorslev (1951) analysis used to estimate the saturated hydraulic conductivity of the screened material (saprolite aquitard). Results of two slug test are shown in Figure 2-6.
